# Manhole Inspection Summary

Manhole # S43E\_\_058MH

**Location** Address: **35 DALLAS-BETHEL-ALLEY** Cross Street: **E LOMBARD ST**

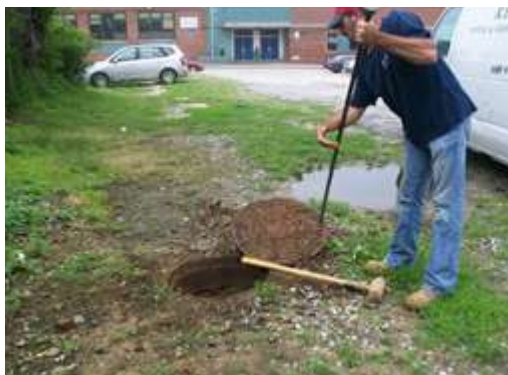
Top View

Comments **HOUSES HAVE BEEN DEMOLISHED AND ALLEY ABANDONED; LOCATED WITH METAL DETECTOR AND EXPOSED -2" BELOW GRADE; FORCED OPEN WITH 16LB MAUL**

FORCED OPEN WITH 16LB MAUL AND DIGGING BAR

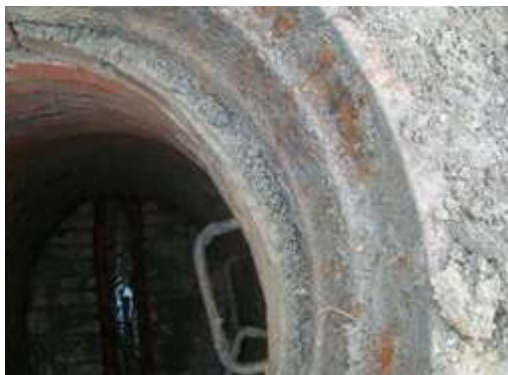
Defect 2

**Frame** Offset: **1.5** (in.) Condition: ☒ Sound ☐ Cracked ☐ Leaks

FRAME OFFSET

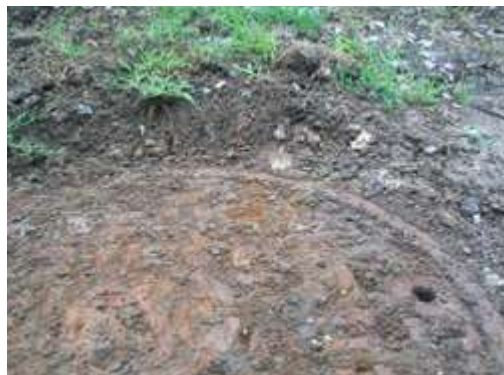
Defect 1

**Cover** Shape: **Circular** Diameter: **24** (in.) Length: **0** (in.) Dist A/B Grade: **-2** (in.)  
Type: **Sanitary** Condition: **Sound** Cover Material: **Cast Iron**  
Properties: ☐ Bolted ☐ Vented ☐ Water Tight ☐ Water Tight Insert

FRAME BELOW GRADE

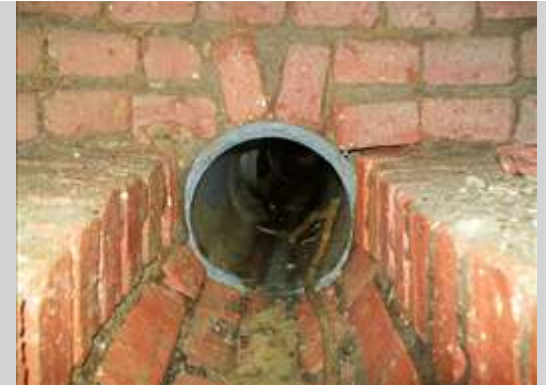
12 O'Clock Outflow

8 in. Circular Gravity Sewer  
Pipe Out @ 12 O'Clock

Pipe Height: **8.4** (in.) Rod and Bar (Angled)  
Pipe Material: **Clay** ☐ Pipe Lined  
Invert Depth: **8.10** (ft.) Flow Characteristics: **Slow**  
Deposits: ☒ None ☐ Mud ☐ Sludge ☐ Debris ☐ Grease  
Silt Depth: **0** (in.) Deposits Extent:  
Infiltration: **None** Pipe Seal Cond: **Sound**

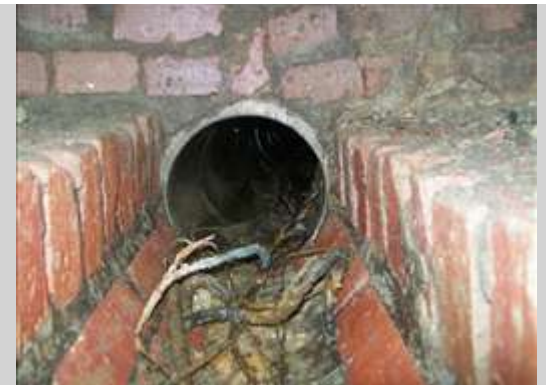
6 O'Clock Inflow

8 in. Circular Gravity Sewer  
Pipe In @ 6 O'Clock

Pipe Height: **8.4** (in.) Rod and Bar (Angled)  
Pipe Material: **Clay** ☐ Pipe Lined  
Invert Depth: **7.90** (ft.) Flow Characteristics: **Slow**  
Deposits: ☒ None ☐ Mud ☐ Sludge ☐ Debris ☐ Grease  
Silt Depth: **0** (in.) Deposits Extent:  
Infiltration: **None** Pipe Seal Cond: **Sound**
